Manhole Inspection Summary

Manhole # S41U1_002MH

Insp Date: **12/12/07 10:16 AM**

Location Address: **508 Baltic Ave**

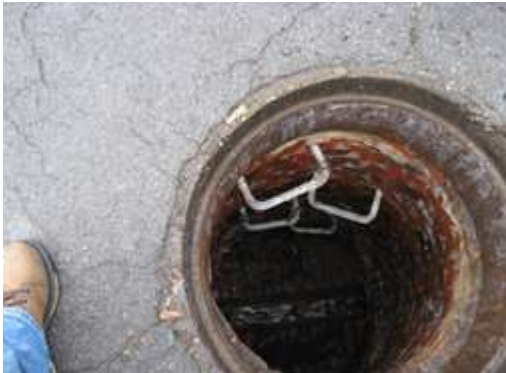
Steps Count: **4** Missing: **0** ☐ Corroded

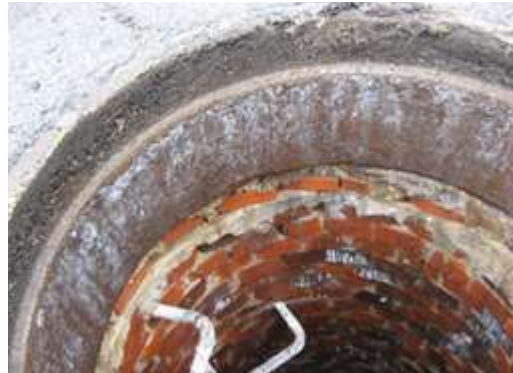
Defect 1

Condition: ☐ Sound ☒ **Cracked** ☐ Root Intrusion ☒ **Loose Brick** ☐ Deteriorated

Chimney loose bricks

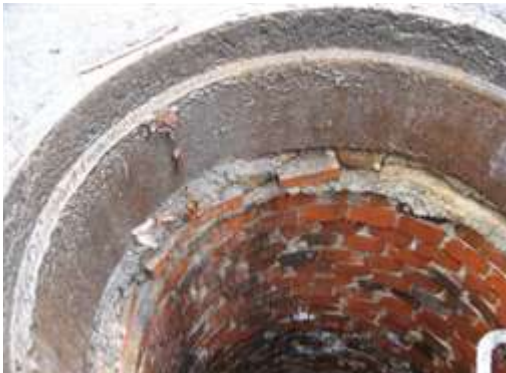
Defect 2

Frame Offset: **1** (in.) Condition: ☒ Sound ☐ Cracked ☐ Leaks

Chimney offset

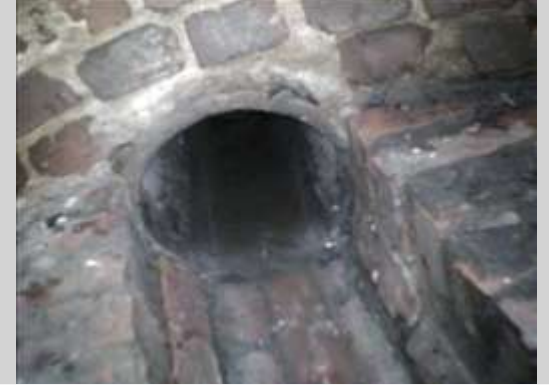
12 O'Clock Outflow

8 in. Circular Gravity Sewer
Pipe Out @ 12 O'Clock

Pipe Height: **9.6** (in.) Rod and Bar (Angled)
Pipe Material: **Clay** ☐ Pipe Lined
Invert Depth: **8.14** (ft.) Flow Characteristics: **Fast**
Deposits: ☒ None ☐ Mud ☐ Sludge ☐ Debris ☐ Grease
Silt Depth: (in.) Deposits Extent:
Infiltration: **None** Pipe Seal Cond: **Sound**

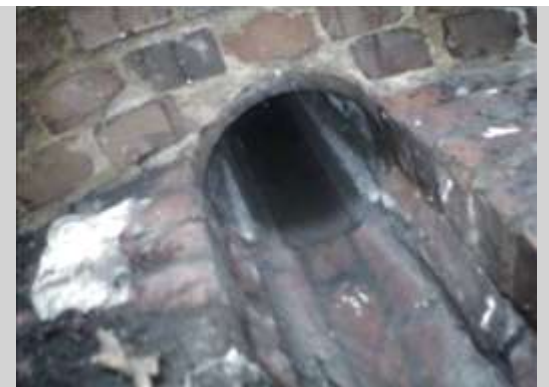
6 O'Clock Inflow

8 in. Circular Gravity Sewer
Pipe In @ 6 O'Clock

Pipe Height: **9.6** (in.) Rod and Bar (Angled)
Pipe Material: **Clay** ☐ Pipe Lined
Invert Depth: **8.04** (ft.) Flow Characteristics: **Fast**
Deposits: ☒ None ☐ Mud ☐ Sludge ☐ Debris ☐ Grease
Silt Depth: (in.) Deposits Extent:
Infiltration: **None** Pipe Seal Cond: **Sound**
